**Flood Control Project Maintenance
Levee Inspections**

Fall 2012 Levee Maintenance Deficiency Summary Report

San Joaquin River Basin

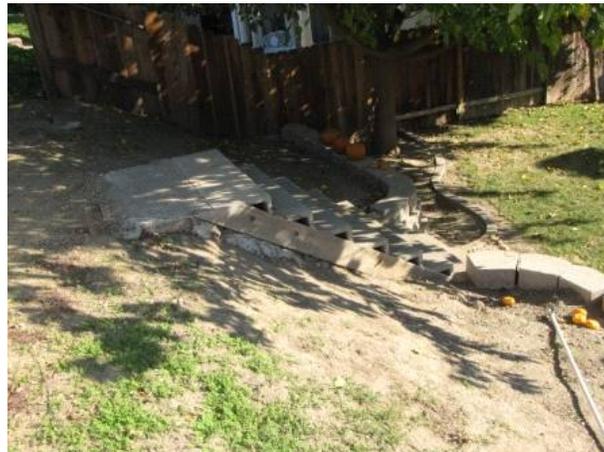
Levee Mile Report Line	27
Start Levee Mile	0.85
End Levee Mile	0.85
Location	Land Side
Category	Earthen Levee
Item	Encroachments
View of steps on the landward slope looking upstream.	
pkazi_f_20120913_211.jpg

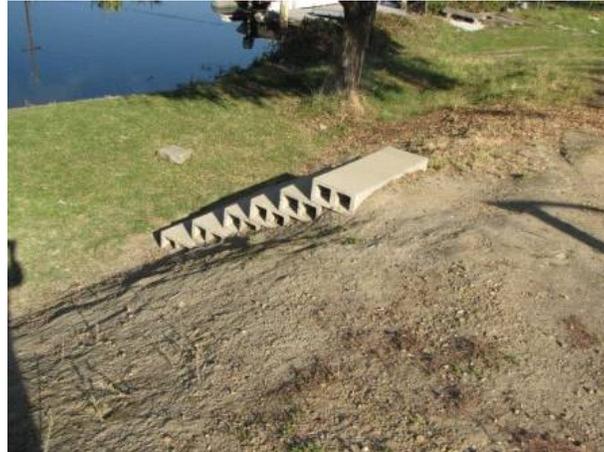
Levee Mile Report Line	28
Start Levee Mile	0.85
End Levee Mile	0.85
Location	Water Side
Category	Earthen Levee
Item	Encroachments
View of steps on the waterward slope looking upstream.	
pkazi_f_20120913_212.jpg

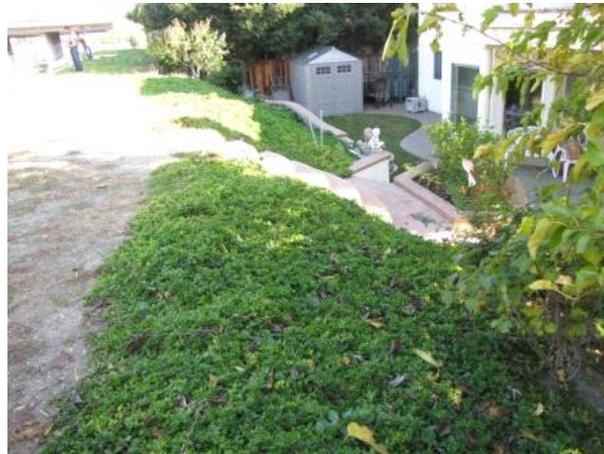
Levee Mile Report Line	29
Start Levee Mile	0.85
End Levee Mile	0.87
Location	Land Side
Category	Earthen Levee
Item	Vegetation
View of landscaping and irrigation on the landward slope looking upstream.	
pkazi_f_20120913_213.jpg

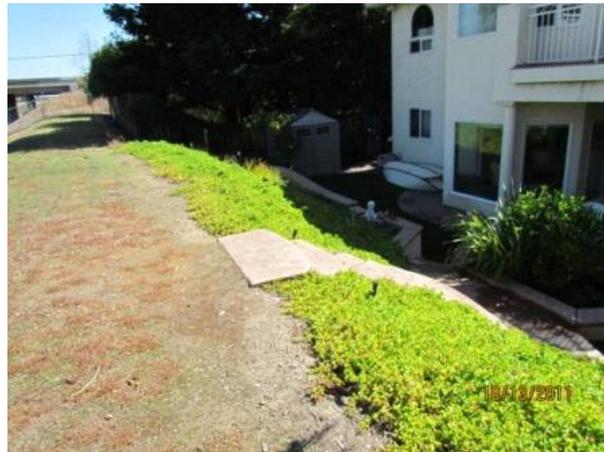
Levee Mile Report Line	29
Start Levee Mile	0.85
End Levee Mile	0.87
Location	Land Side
Category	Earthen Levee
Item	Vegetation
View of landscaping on the landside of the levee looking upstream. This picture was taken during fall 2011 inspection.	
pkazi_f_20120913_214.jpg

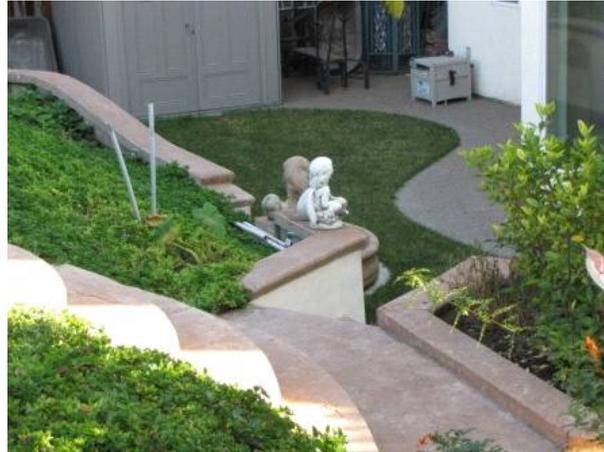
View of a retaining wall and patio in the landward slope.

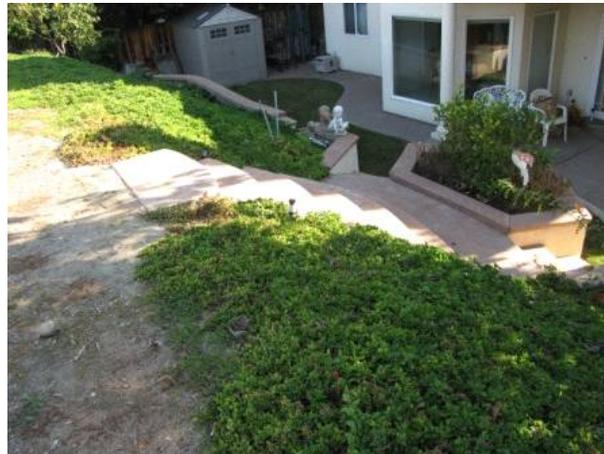
Levee Mile Report Line	31
Start Levee Mile	0.86
End Levee Mile	0.86
Location	Land Side
Category	Earthen Levee
Item	Encroachments

View of steps on the landward slope looking upstream.

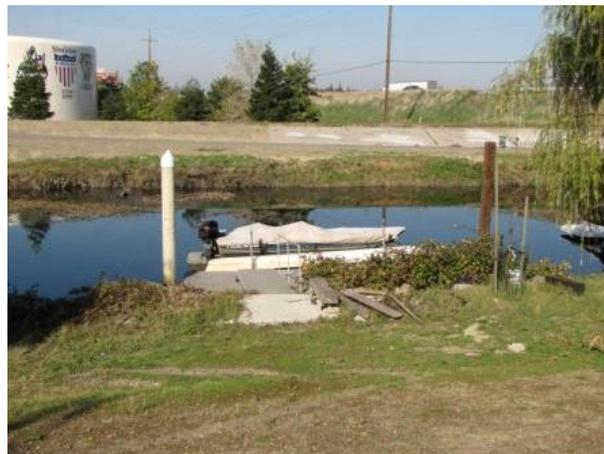
Levee Mile Report Line	32
Start Levee Mile	0.86
End Levee Mile	0.86
Location	Water Side
Category	Earthen Levee
Item	Encroachments

View of a dock and concrete pad on the waterward side of the berm.

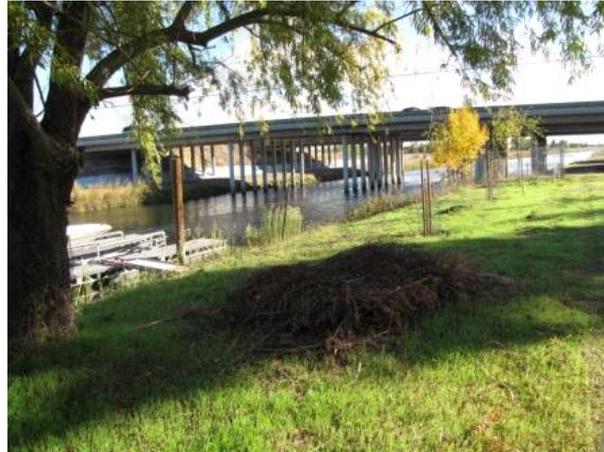
Levee Mile Report Line	33
Start Levee Mile	0.87
End Levee Mile	0.87
Location	Water Side
Category	Earthen Levee
Item	Encroachments
View of a prunings pile on the waterward berm looking upstream.	
pkazi_f_20120913_108.jpg

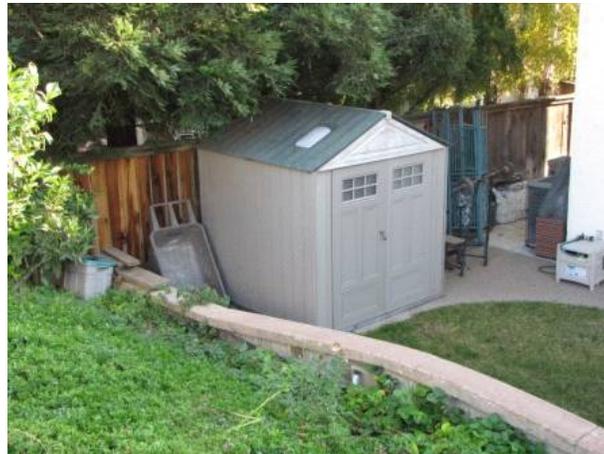
Levee Mile Report Line	34
Start Levee Mile	0.87
End Levee Mile	0.87
Location	Land Side
Category	Earthen Levee
Item	Encroachments
View of a shed located at the landward toe looking upstream.	
pkazi_f_20120913_218.jpg

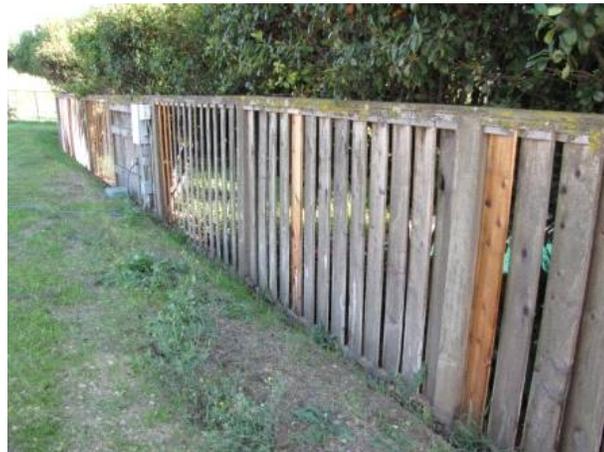
Levee Mile Report Line	35
Start Levee Mile	0.87
End Levee Mile	0.88
Location	Land Side
Category	Earthen Levee
Item	Encroachments
View of a fence at the landward shoulder blocking visibility and access looking upstream. Some encroachments can be seen through the fence but not with any detail. Also visible is an electrical panel and hose bib.	
pkazi_f_20120913_219.jpg

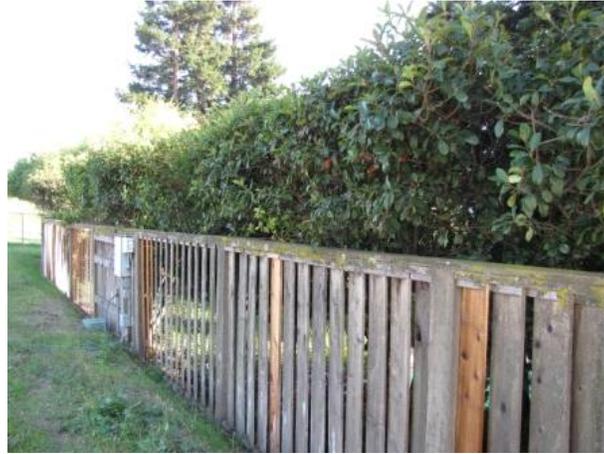
Levee Mile Report Line	36
Start Levee Mile	0.87
End Levee Mile	0.88
Location	Land Side
Category	Earthen Levee
Item	Vegetation
View of bushes above the fence at the landward shoulder further obstructing visibility looking upstream.	
pkazi_f_20120913_220.jpg

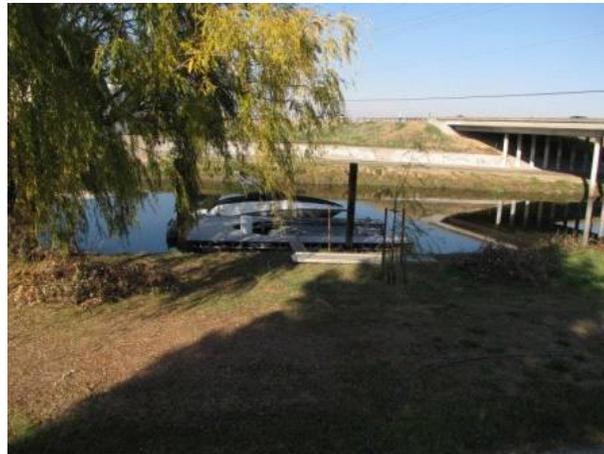
Levee Mile Report Line	37
Start Levee Mile	0.88
End Levee Mile	0.88
Location	Water Side
Category	Earthen Levee
Item	Encroachments
View of a dock on the waterward side of the berm.	
pkazi_f_20120913_221.jpg

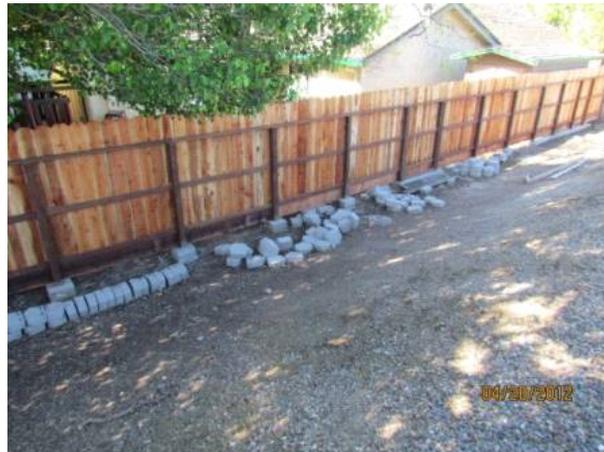
Levee Mile Report Line	38
Start Levee Mile	1.02
End Levee Mile	1.02
Location	Land Side
Category	Earthen Levee
Item	Encroachments
Debris was found on the landside toe of the levee looking downstream.	
pkazi_f_20120913_132.jpg

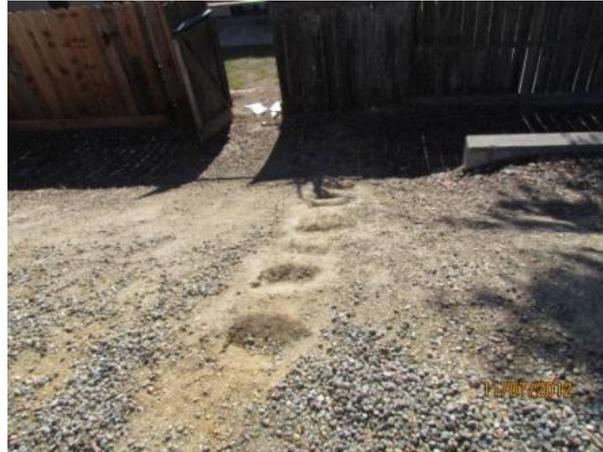
Levee Mile Report Line	39
Start Levee Mile	1.19
End Levee Mile	1.19
Location	Land Side
Category	Earthen Levee
Item	Encroachments
Steps were dug into the landside slope of the levee looking downstream.	
pkazi_f_20121108_018.jpg

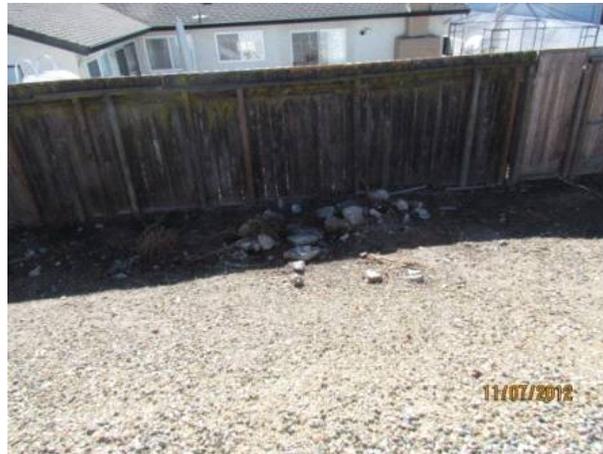
Levee Mile Report Line	41
Start Levee Mile	1.45
End Levee Mile	1.45
Location	Land Side
Category	Earthen Levee
Item	Encroachments
Debris was found on the landside toe of the levee looking downstream.	
pkazi_f_20121108_017.jpg

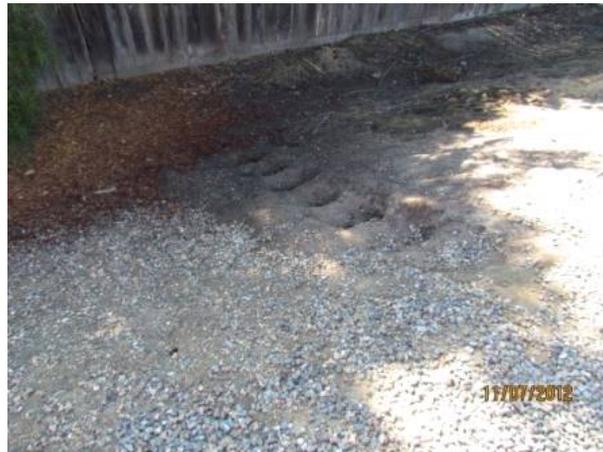
Levee Mile Report Line	42
Start Levee Mile	1.48
End Levee Mile	1.48
Location	Land Side
Category	Earthen Levee
Item	Encroachments
Steps were dug into the landside slope of the levee looking downstream.	
pkazi_f_20121108_016.jpg

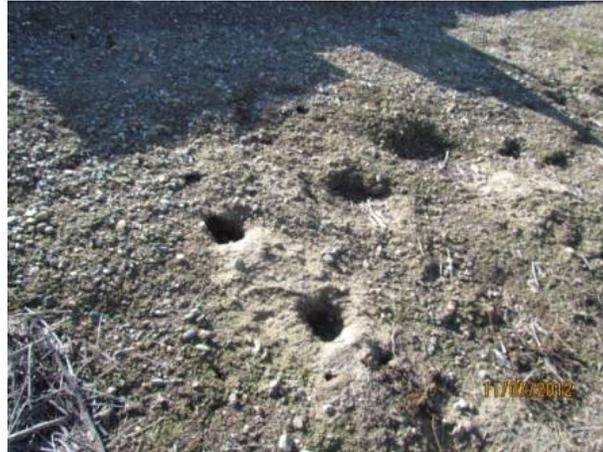
Levee Mile Report Line	43
Start Levee Mile	1.49
End Levee Mile	1.49
Location	Water Side
Category	Earthen Levee
Item	Animal Control
<p>Animal holes were found on the waterside slope of the levee looking downstream.</p>	
<p>pkazi_f_20121108_015.jpg</p>

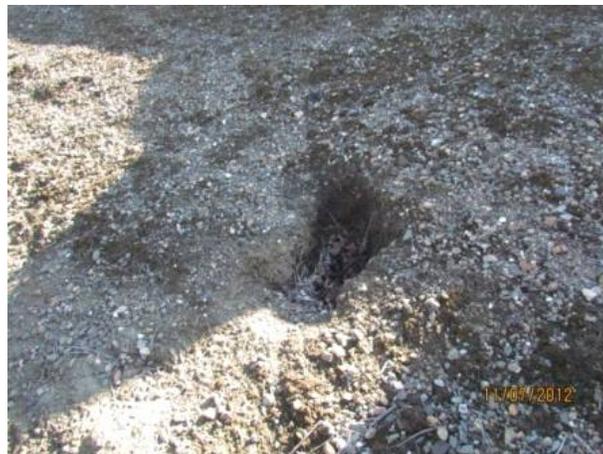
Levee Mile Report Line	44
Start Levee Mile	1.57
End Levee Mile	1.57
Location	Water Side
Category	Earthen Levee
Item	Animal Control
<p>An animal hole was found on the waterside slope of the levee looking upstream.</p>	
<p>pkazi_f_20121108_019.jpg</p>

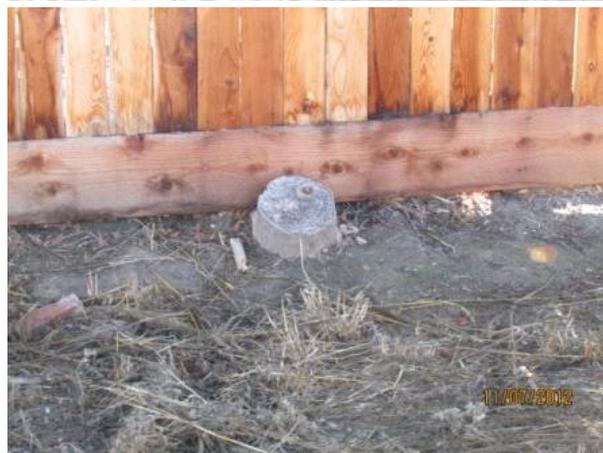
Levee Mile Report Line	45
Start Levee Mile	1.73
End Levee Mile	1.73
Location	Land Side
Category	Earthen Levee
Item	Trim / Thin Trees
<p>A tree stump was found on the landside toe of the levee. The picture was taken from the crown looking towards the toe.</p>	
<p>pkazi_f_20121108_014.jpg</p>

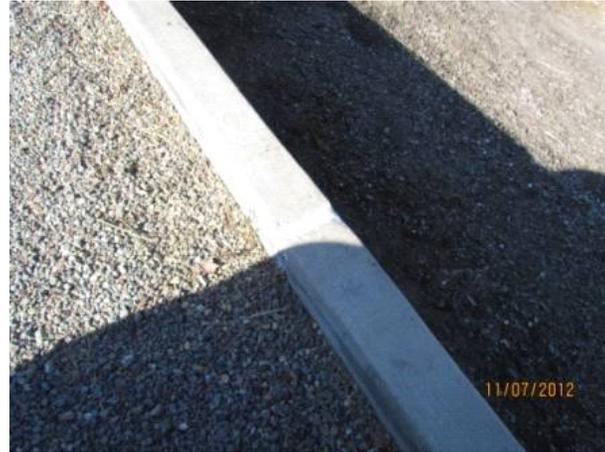
Levee Mile Report Line	47
Start Levee Mile	1.74
End Levee Mile	1.74
Location	Water Side
Category	Concrete Floodwalls
Item	Monolith Joints
LMA repaired the monolith joint at this location. The picture was taken from the crown looking downstream.	
pkazi_f_20121108_013.jpg

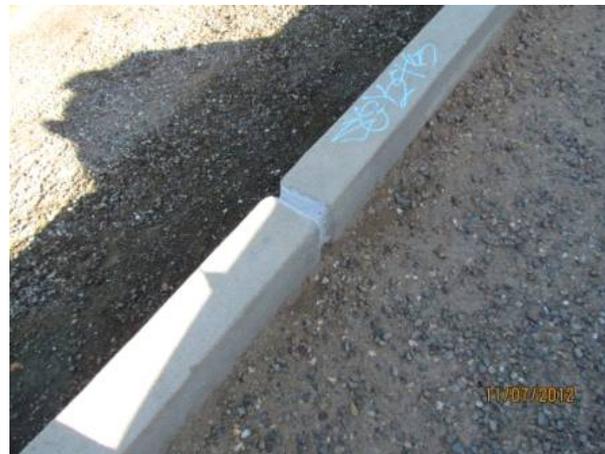
Levee Mile Report Line	49
Start Levee Mile	1.89
End Levee Mile	1.89
Location	Water Side
Category	Concrete Floodwalls
Item	Monolith Joints
LMA repaired the monolith joint at this location. The picture was taken from the crown looking upstream.	
pkazi_f_20121108_012.jpg

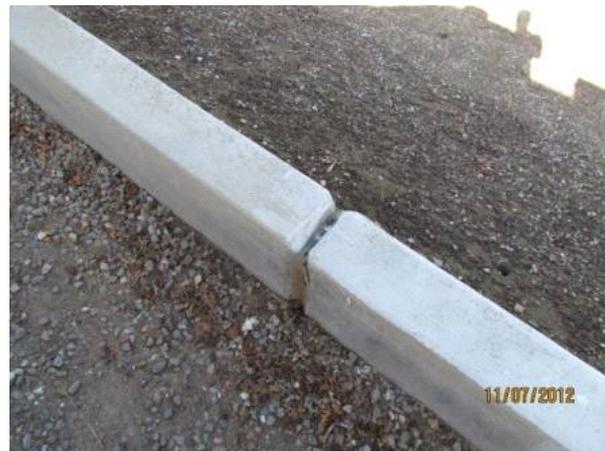
Levee Mile Report Line	50
Start Levee Mile	1.97
End Levee Mile	1.97
Location	Water Side
Category	Concrete Floodwalls
Item	Monolith Joints
The monolith joint material is deteriorating at this location. The picture was taken from crown looking downstream.	
pkazi_f_20121108_011.jpg

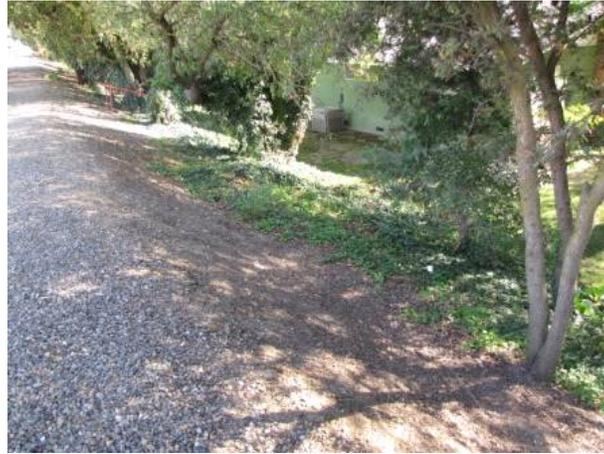
Levee Mile Report Line	51
Start Levee Mile	2.04
End Levee Mile	2.07
Location	Land Side
Category	Earthen Levee
Item	Vegetation
View of landscaping along the landward slope looking upstream. County crews have greatly reduced the amount of material and increased visibility and access.	
pkazi_f_20120913_170.jpg

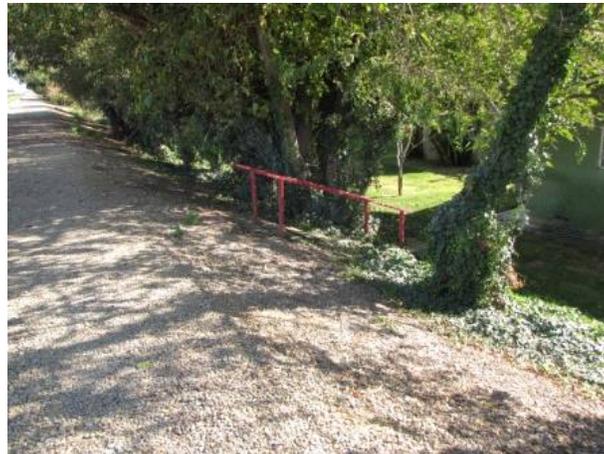
Levee Mile Report Line	52
Start Levee Mile	2.06
End Levee Mile	2.06
Location	Land Side
Category	Earthen Levee
Item	Encroachments
View of steps dug into the landward slope looking upstream.	
pkazi_f_20120913_171.jpg

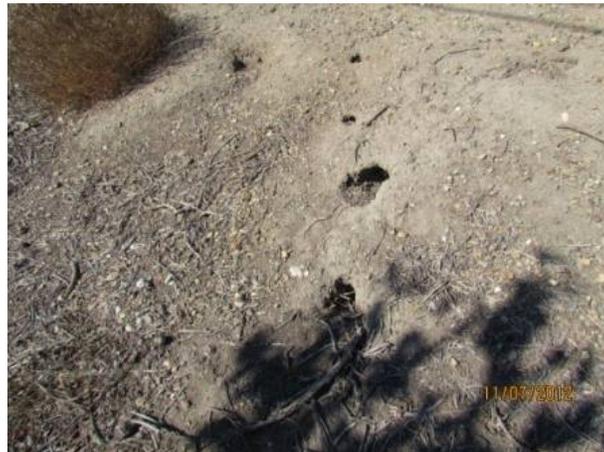
Levee Mile Report Line	53
Start Levee Mile	2.10
End Levee Mile	2.10
Location	Land Side
Category	Earthen Levee
Item	Animal Control
Animal holes were found on the landside of the levee looking upstream.	
pkazi_f_20121108_020.jpg

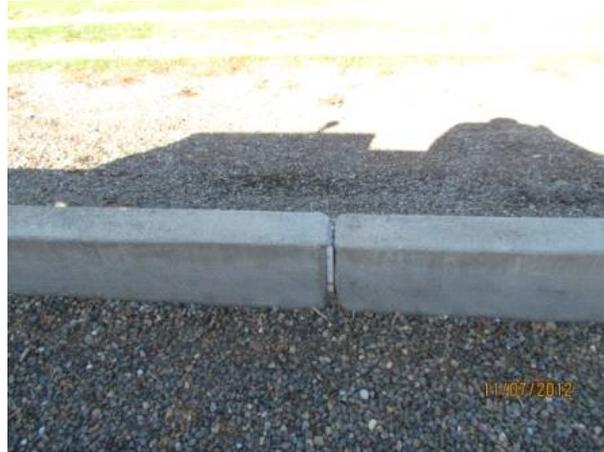
Levee Mile Report Line	54
Start Levee Mile	2.11
End Levee Mile	2.11
Location	Water Side
Category	Concrete Floodwalls
Item	Monolith Joints
<p>Monolith joint is deteriorating at this location of the wall. The picture was taken from the crown looking upstream.</p>	
<p>pkazi_f_20121108_021.jpg</p>

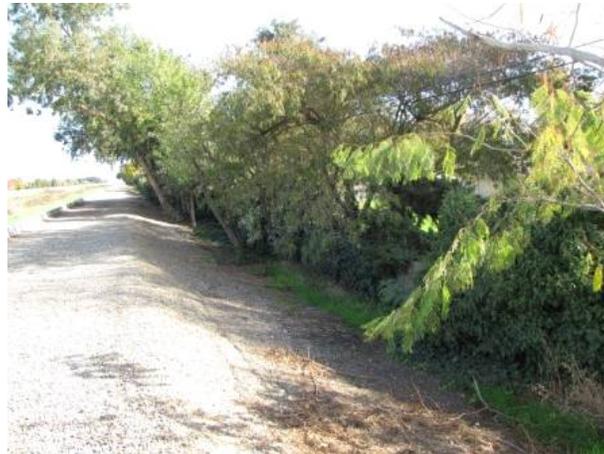
Levee Mile Report Line	55
Start Levee Mile	2.11
End Levee Mile	2.14
Location	Land Side
Category	Earthen Levee
Item	Encroachments
<p>View of a fence with landscaping growing on it at the landward toe looking upstream.</p>	
<p>pkazi_f_20120913_172.jpg</p>

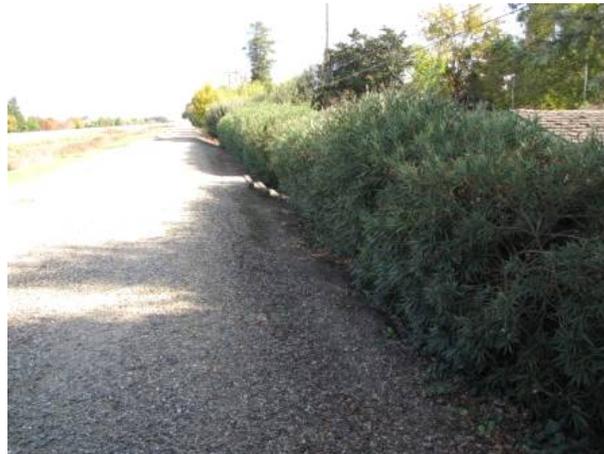
Levee Mile Report Line	56
Start Levee Mile	2.14
End Levee Mile	2.16
Location	Land Side
Category	Earthen Levee
Item	Vegetation
<p>View of landscaping along the landward slope looking upstream.</p>	
<p>pkazi_f_20120913_173.jpg</p>

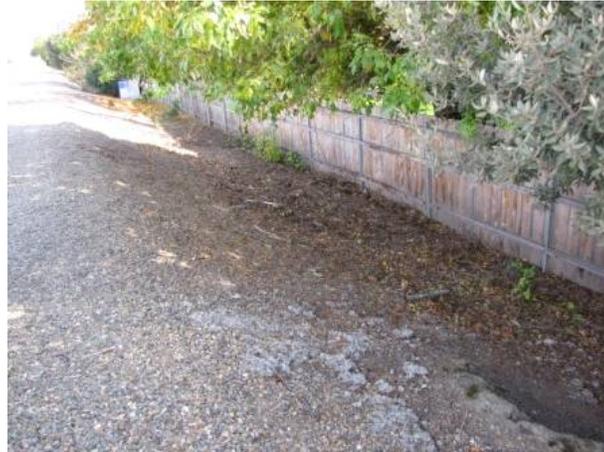
Levee Mile Report Line	58
Start Levee Mile	2.17
End Levee Mile	2.19
Location	Land Side
Category	Earthen Levee
Item	Encroachments
View of a fence along the landward toe looking upstream.	
pkazi_f_20120913_174.jpg

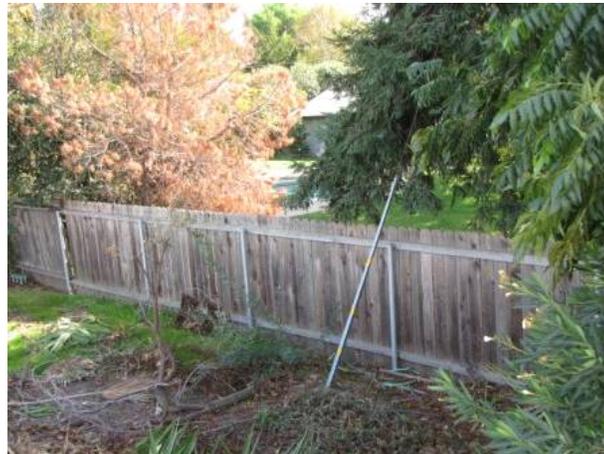
Levee Mile Report Line	60
Start Levee Mile	2.19
End Levee Mile	2.25
Location	Land Side
Category	Earthen Levee
Item	Encroachments
View of a fence along the landward toe looking upstream.	
pkazi_f_20120913_175.jpg

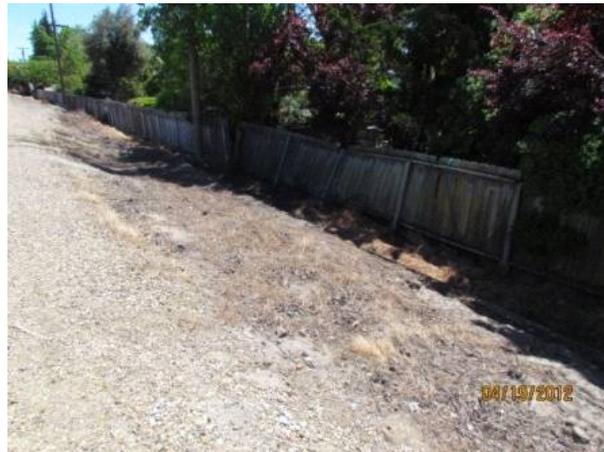
Levee Mile Report Line	60
Start Levee Mile	2.19
End Levee Mile	2.25
Location	Land Side
Category	Earthen Levee
Item	Encroachments
Fence was located on the landside toe of the levee looking upstream. This picture was taken during spring 2012 inspection.	
pkazi_f_20120913_176.jpg

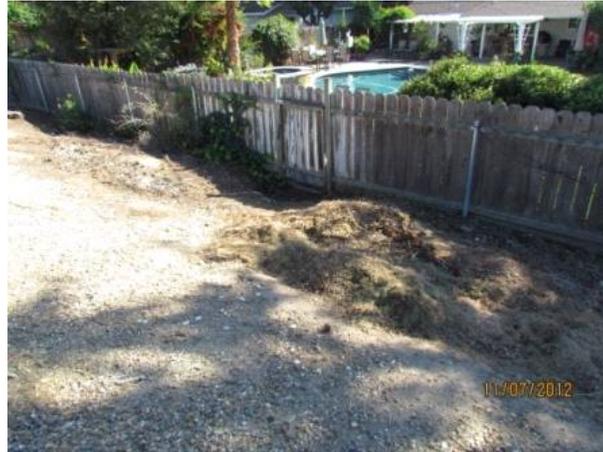
Levee Mile Report Line	61
Start Levee Mile	2.22
End Levee Mile	2.22
Location	Land Side
Category	Earthen Levee
Item	Encroachments
Debris was found on the landside toe of the levee looking upstream.	
pkazi_f_20121108_022.jpg

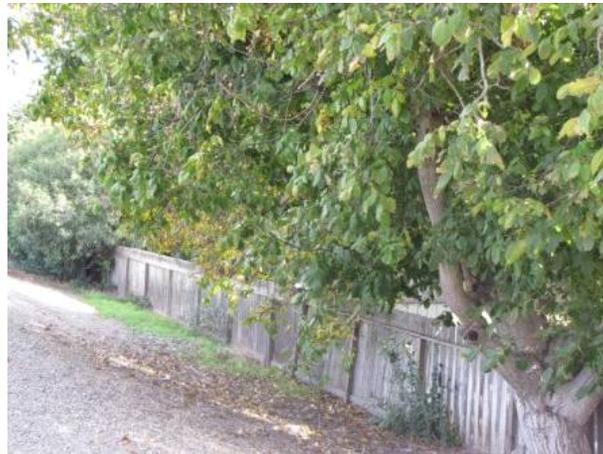
Levee Mile Report Line	62
Start Levee Mile	2.25
End Levee Mile	2.30
Location	Land Side
Category	Earthen Levee
Item	Encroachments
View of a wood fence at the landward toe.	
pkazi_f_20120913_177.jpg

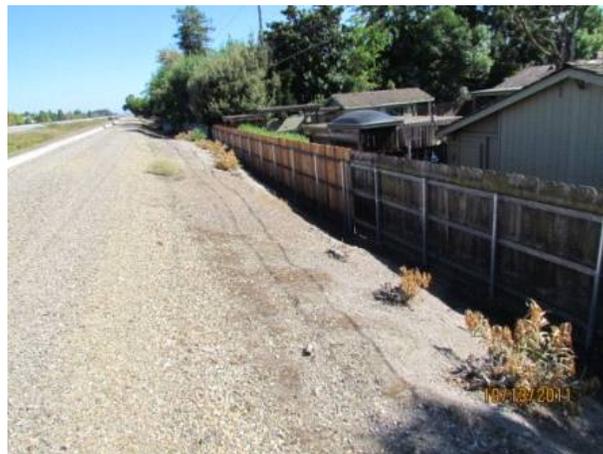
Levee Mile Report Line	62
Start Levee Mile	2.25
End Levee Mile	2.30
Location	Land Side
Category	Earthen Levee
Item	Encroachments
View of the fence on the landside toe of the levee looking upstream. This picture was taken during fall 2011 inspection.	
pkazi_f_20120913_178.jpg

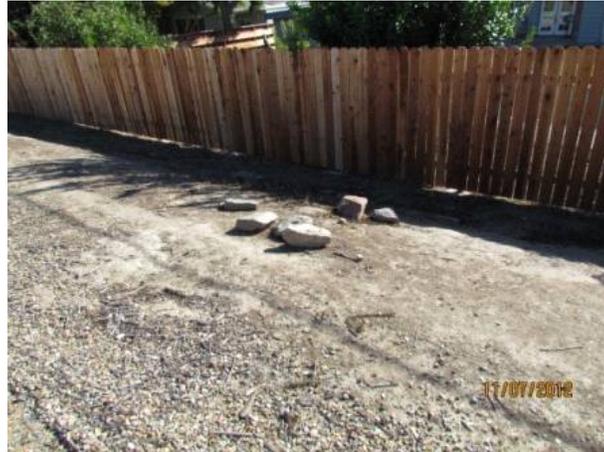
Levee Mile Report Line	63
Start Levee Mile	2.29
End Levee Mile	2.29
Location	Land Side
Category	Earthen Levee
Item	Encroachments
Concrete debris was found on the landside toe of the levee looking upstream.	
pkazi_f_20121108_023.jpg

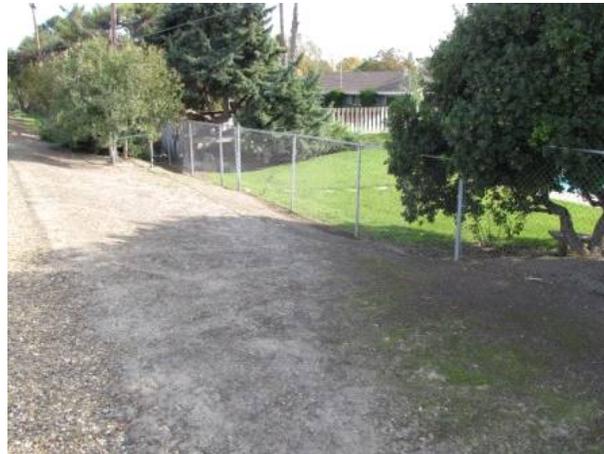
Levee Mile Report Line	64
Start Levee Mile	2.30
End Levee Mile	2.38
Location	Land Side
Category	Earthen Levee
Item	Encroachments
View of a fence on the landward slope looking upstream.	
pkazi_f_20120913_179.jpg

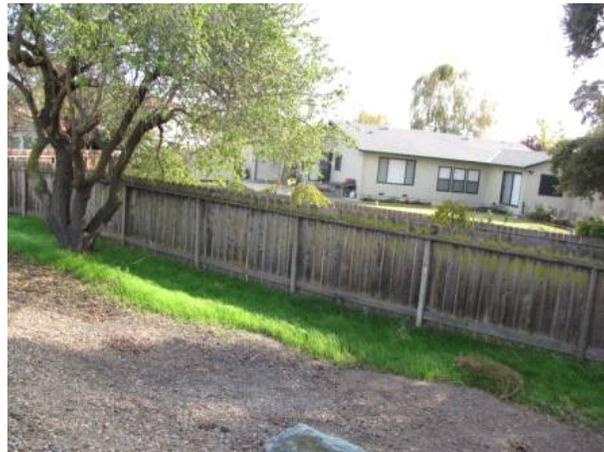
Levee Mile Report Line	67
Start Levee Mile	2.38
End Levee Mile	2.40
Location	Land Side
Category	Earthen Levee
Item	Encroachments
View of a fence at the landward toe.	
pkazi_f_20120913_180.jpg

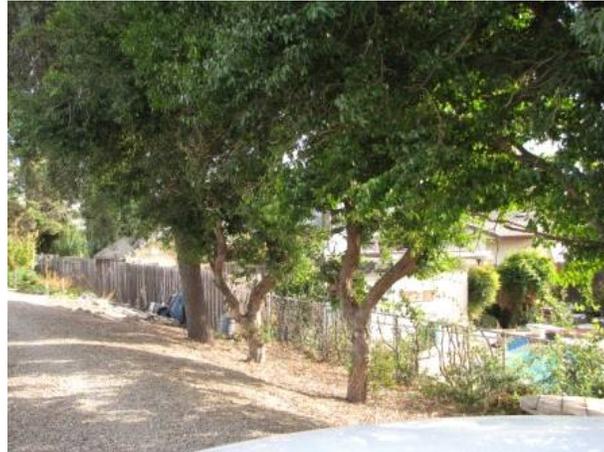
pkazi_f_20120913_181.jpg

View of a fence at the landward toe.

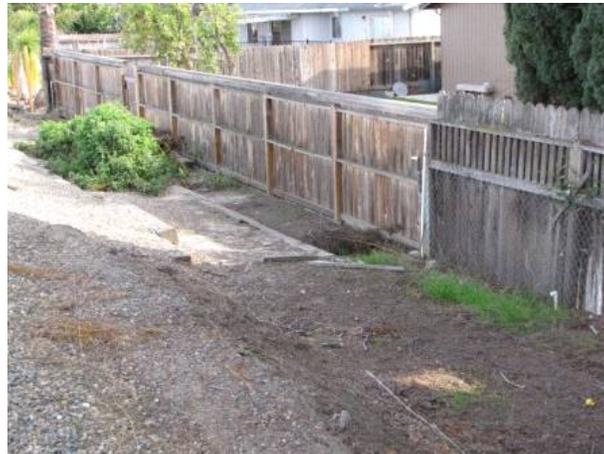
pkazi_f_20120913_182.jpg

Levee Mile Report Line	70
Start Levee Mile	2.43
End Levee Mile	2.69
Location	Land Side
Category	Earthen Levee
Item	Encroachments

View of a fence at the landward toe looking upstream.

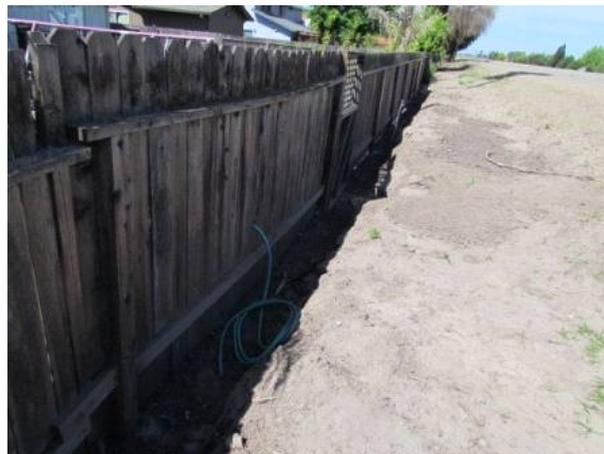
pkazi_f_20120913_127.jpg

Levee Mile Report Line	72
Start Levee Mile	2.48
End Levee Mile	2.48
Location	Land Side
Category	Earthen Levee
Item	Encroachments

The owner excavated a ditch on the toe at the landside of the levee. The picture was taken from the landside of the levee looking downstream.

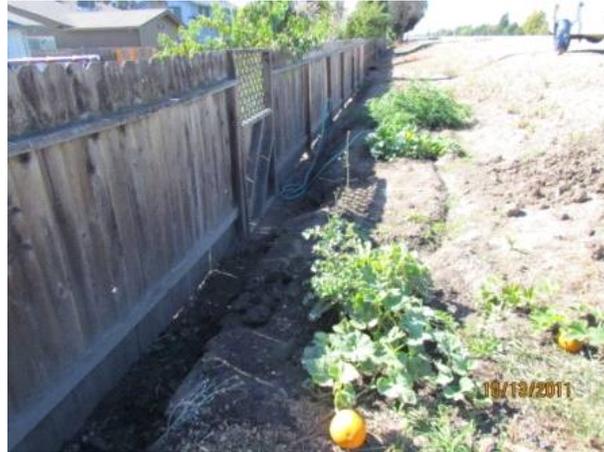
pkazi_f_20120913_128.jpg

View of a ditch at the landside toe of the levee looking downstream.

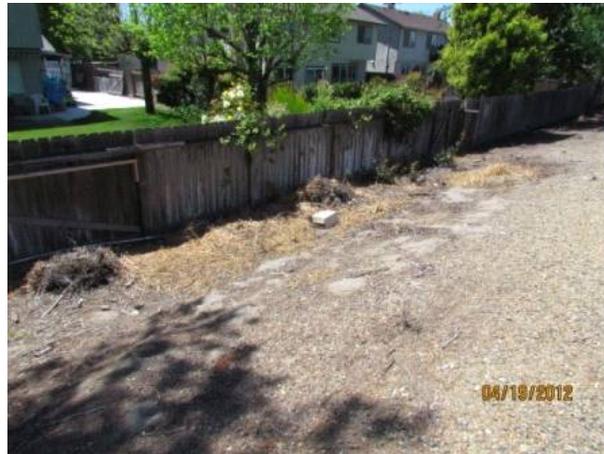
pkazi_f_20120913_123.jpg

Levee Mile Report Line	73
Start Levee Mile	2.53
End Levee Mile	2.53
Location	Land Side
Category	Earthen Levee
Item	Encroachments

Debris was found on the landside of the levee looking downstream.

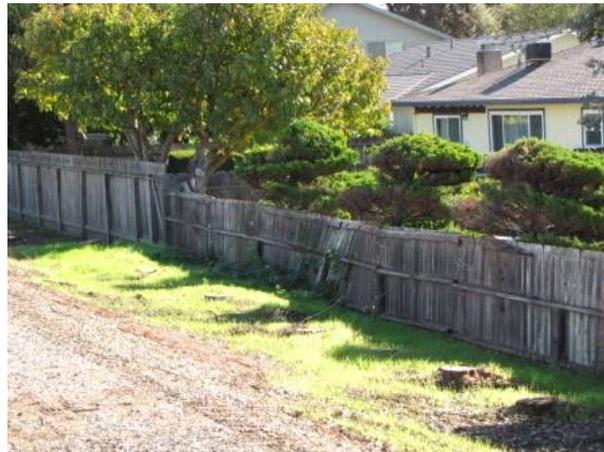
pkazi_f_20120913_110.jpg

Levee Mile Report Line	74
Start Levee Mile	2.55
End Levee Mile	2.55
Location	Land Side
Category	Earthen Levee
Item	Trim / Thin Trees

View of stumps along the landward toe looking upstream.

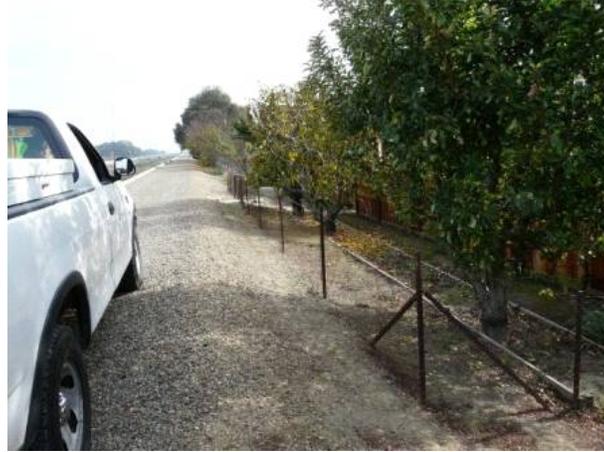
Levee Mile Report Line	76
Start Levee Mile	2.58
End Levee Mile	2.61
Location	Land Side
Category	Earthen Levee
Item	Encroachments
Fence located on sholder of landside of levee from LM 2.58 to LM 2.61	
pkazi_f_20120913_126.JPG

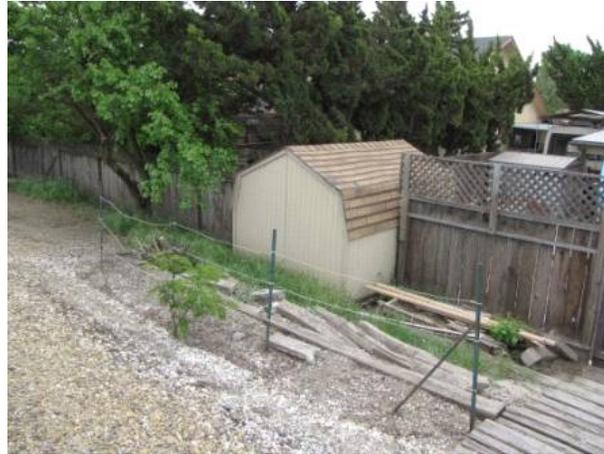
Levee Mile Report Line	78
Start Levee Mile	2.61
End Levee Mile	2.61
Location	Land Side
Category	Earthen Levee
Item	Encroachments
Landscaping and shed placed on landward levee slope and within 10' of the toe.	
pkazi_f_20120913_169.jpg

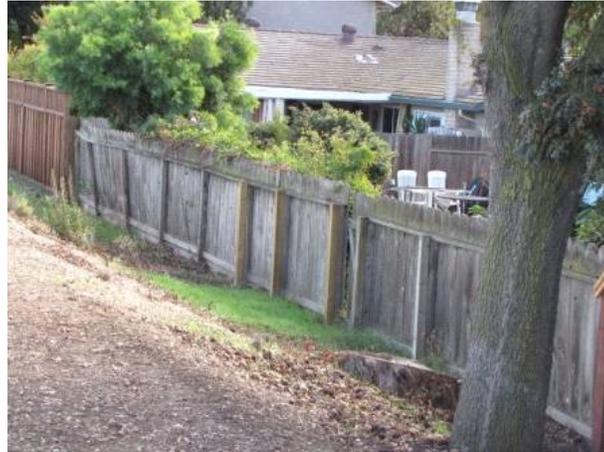
Levee Mile Report Line	89
Start Levee Mile	3.08
End Levee Mile	3.08
Location	Land Side
Category	Earthen Levee
Item	Trim / Thin Trees
View of a stump on the landward slope looking upstream.	
pkazi_f_20120913_111.jpg

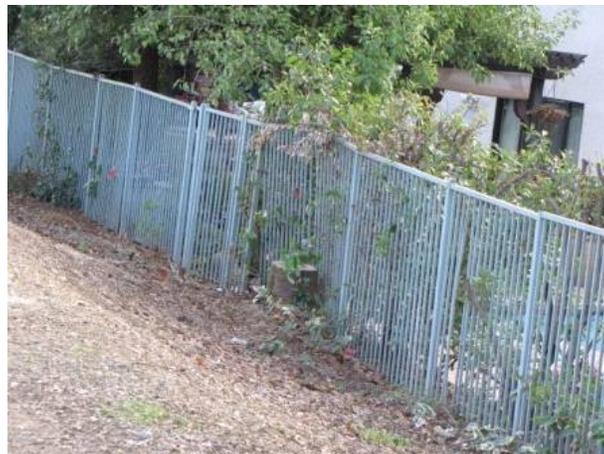
Levee Mile Report Line	90
Start Levee Mile	3.15
End Levee Mile	3.15
Location	Land Side
Category	Earthen Levee
Item	Trim / Thin Trees
View of a stump on the landward slope looking upstream.	
pkazi_f_20120913_112.jpg

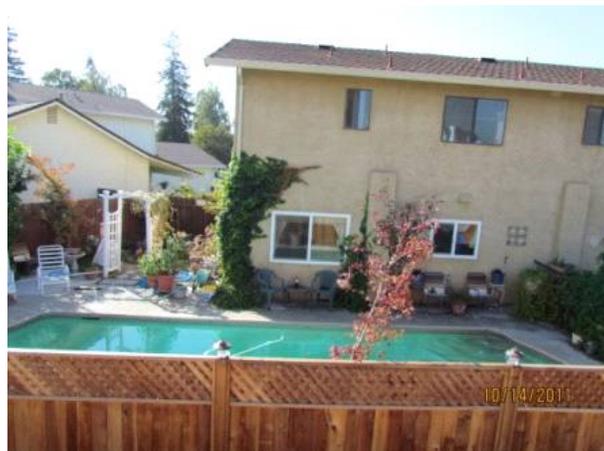
Levee Mile Report Line	91
Start Levee Mile	3.15
End Levee Mile	3.15
Location	Land Side
Category	Earthen Levee
Item	Encroachments
View of the pool located within 10 feet from the toe of the landside of the levee. The picture was taken from the crown looking towards the toe.	
pkazi_f_20120913_160.jpg

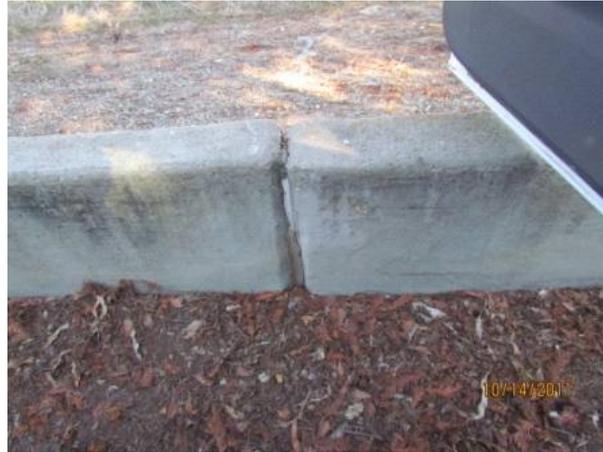
Levee Mile Report Line	93
Start Levee Mile	3.22
End Levee Mile	3.22
Location	Land Side
Category	Concrete Floodwalls
Item	Monolith Joints
<p>Monolith joint material is deteriorating at the joint of the flood wall. The picture was taken from the crown looking upstream.</p>	
<p>pkazi_f_20120913_162.jpg</p>

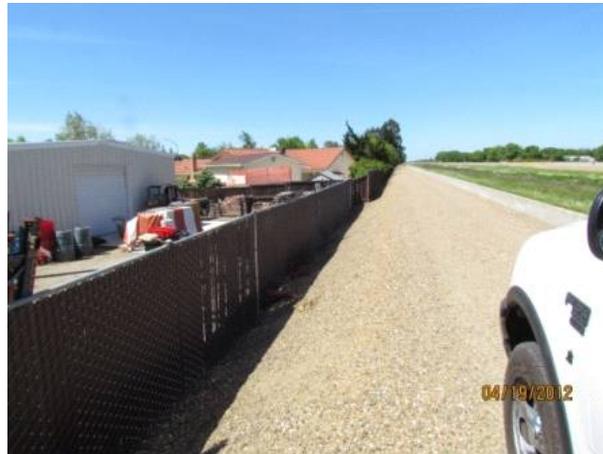
Levee Mile Report Line	94
Start Levee Mile	3.34
End Levee Mile	3.41
Location	Land Side
Category	Earthen Levee
Item	Encroachments
<p>Fences were found on the landside of the levee looking downstream.</p>	
<p>pkazi_f_20120913_152.jpg</p>

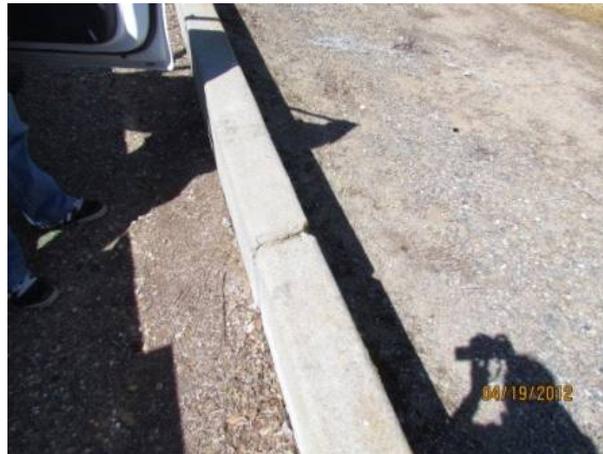
Levee Mile Report Line	95
Start Levee Mile	3.40
End Levee Mile	3.40
Location	Water Side
Category	Concrete Floodwalls
Item	Monolith Joints
<p>The monolith joint material is deteriorating on the waterside of the levee looking downstream.</p>	
<p>pkazi_f_20120913_119.jpg</p>

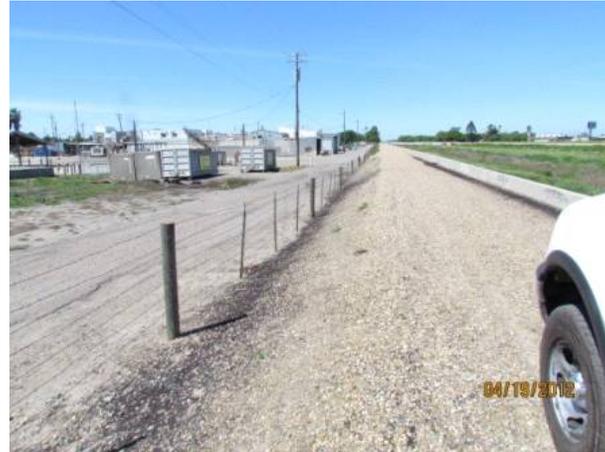
Levee Mile Report Line	98
Start Levee Mile	3.56
End Levee Mile	3.72
Location	Land Side
Category	Earthen Levee
Item	Encroachments
Fences were found on the landside toe of the levee looking downstream.	
pkazi_f_20120913_114.jpg

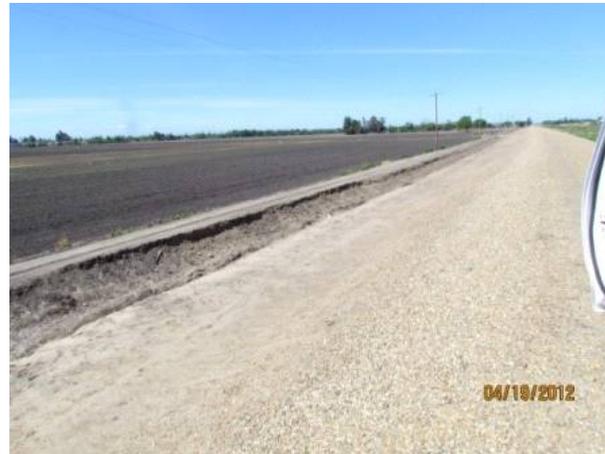
Levee Mile Report Line	99
Start Levee Mile	4.45
End Levee Mile	4.66
Location	Land Side
Category	Earthen Levee
Item	Encroachments
An agricultural ditch was found on the landside of the levee looking downstream.	
pkazi_f_20120913_115.jpg

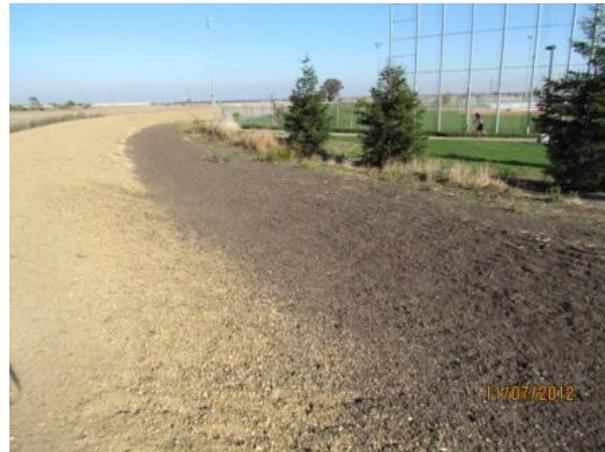
Levee Mile Report Line	101
Start Levee Mile	4.73
End Levee Mile	4.73
Location	Land Side
Category	Earthen Levee
Item	Slope Stability
LMA has fixed an ongoing slope instability issue at the toe of the landside of the levee looking upstream.	
pkazi_f_20121108_024.jpg

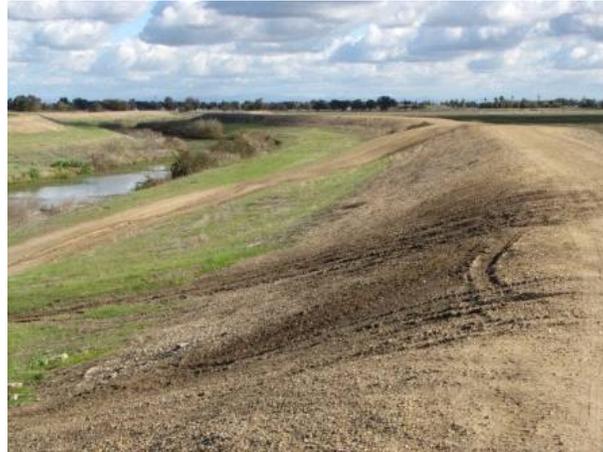
Levee Mile Report Line	103
Start Levee Mile	6.24
End Levee Mile	6.24
Location	Water Side
Category	Earthen Levee
Item	Slope Stability
View of damage to the waterward slope of the levee due to vehicle traffic looking upstream.	
pkazi_f_20120913_117.jpg

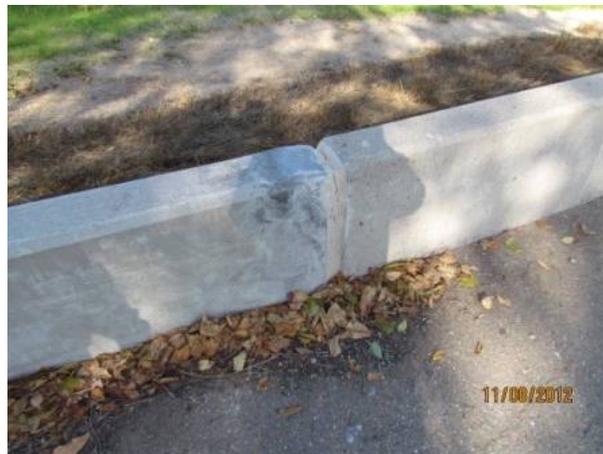
Levee Mile Report Line	109
Start Levee Mile	7.57
End Levee Mile	7.57
Location	Water Side
Category	Concrete Floodwalls
Item	Monolith Joints
LMA repaired the monolith joint at this location. The picture was taken from the crown looking upstream.	
pkazi_f_20121108_025.jpg

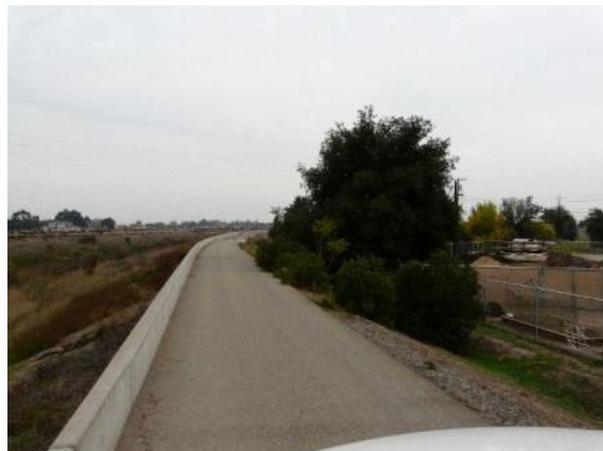
Levee Mile Report Line	110
Start Levee Mile	7.57
End Levee Mile	7.62
Location	Land Side
Category	Earthen Levee
Item	Vegetation
Landscaping along landside slope of levee from LM 7.57 to 7.62	
pkazi_f_20120913_135.JPG

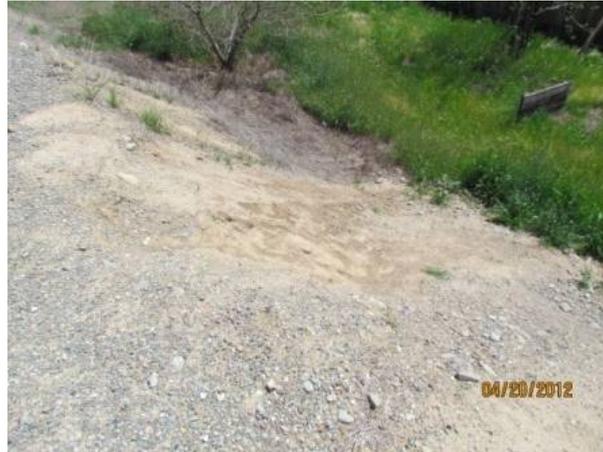
Levee Mile Report Line	111
Start Levee Mile	7.65
End Levee Mile	7.65
Location	Land Side
Category	Earthen Levee
Item	Slope Stability
Erosion was found on the landside of the levee looking upstream.	
pkazi_f_20120913_133.jpg

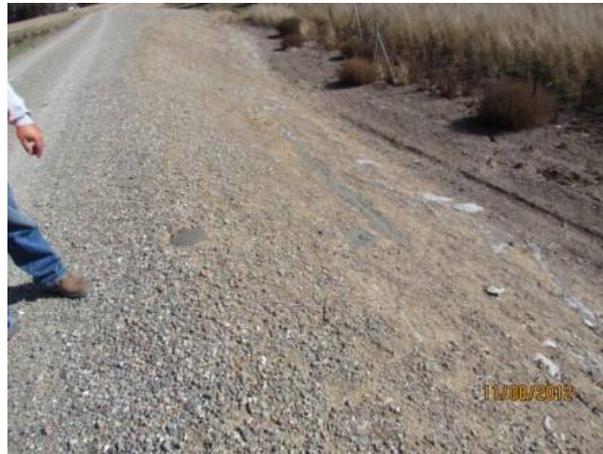
Levee Mile Report Line	113
Start Levee Mile	8.30
End Levee Mile	8.30
Location	Land Side
Category	Earthen Levee
Item	Animal Control
LMA fixed the animal holes at the landside slope of the levee looking upstream.	
pkazi_f_20121108_026.jpg

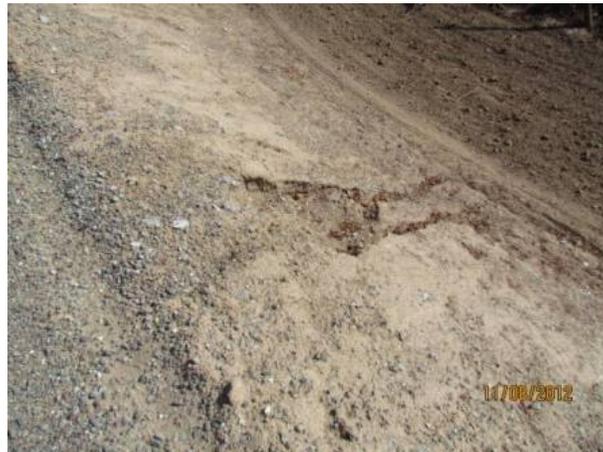
Levee Mile Report Line	114
Start Levee Mile	9.48
End Levee Mile	9.48
Location	Land Side
Category	Earthen Levee
Item	Slope Stability
Slope instability was found on the landside slope of the levee looking upstream.	
pkazi_f_20121108_027.jpg

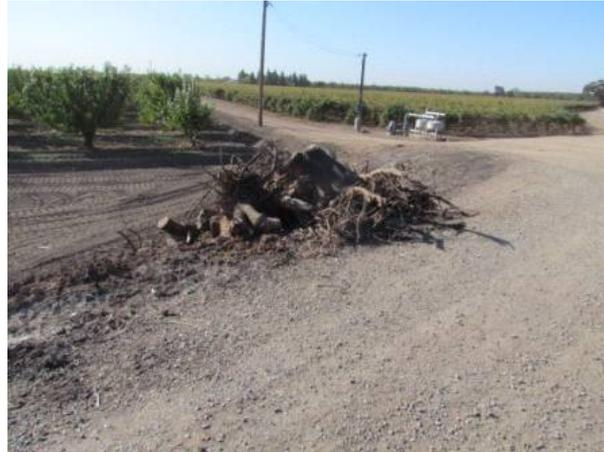
Levee Mile Report Line	115
Start Levee Mile	9.52
End Levee Mile	9.52
Location	Land Side
Category	Earthen Levee
Item	Encroachments
<p>Prunings were found on the landside of the levee looking upstream.</p>	
<p>pkazi_f_20120913_136.jpg</p>

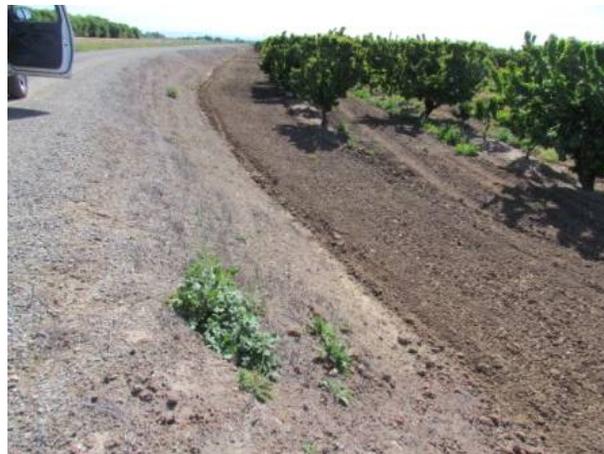
Levee Mile Report Line	116
Start Levee Mile	9.54
End Levee Mile	9.60
Location	Land Side
Category	Earthen Levee
Item	Encroachments
<p>Tilling was done by the farmers at the landside toe of the levee. The picture was taken from the crown of the levee looking upstream.</p>	
<p>pkazi_f_20120913_153.jpg</p>

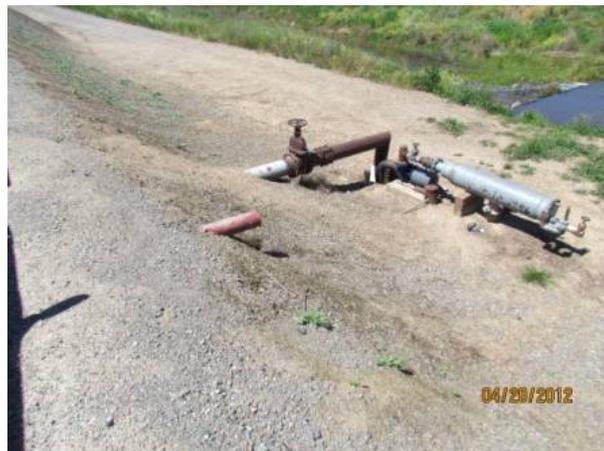
Levee Mile Report Line	118
Start Levee Mile	9.75
End Levee Mile	9.75
Location	Water Side
Category	Earthen Levee
Item	Encroachments
<p>An open pipe was found on the waterside of the levee looking downstream.</p>	
<p>pkazi_f_20120913_137.jpg</p>

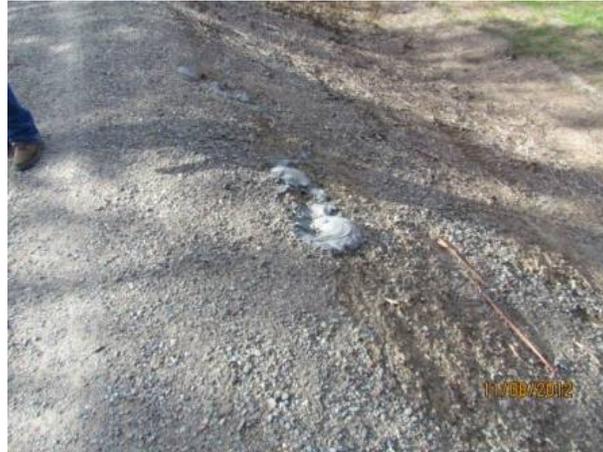
Levee Mile Report Line	122
Start Levee Mile	10.28
End Levee Mile	10.28
Location	Water Side
Category	Earthen Levee
Item	Animal Control
<p>The animal hole was grouted on the waterside shoulder of the levee looking downstream.</p>	
<p>pkazi_f_20121109_028.jpg</p>

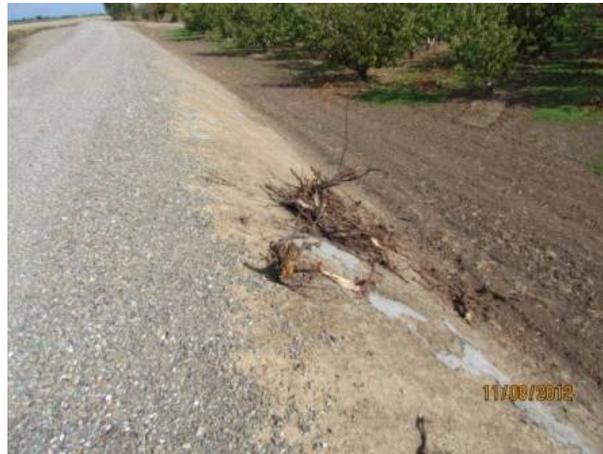
Levee Mile Report Line	126
Start Levee Mile	11.38
End Levee Mile	11.38
Location	Land Side
Category	Earthen Levee
Item	Encroachments
<p>Debris was found on the landside slope of the levee looking upstream.</p>	
<p>pkazi_f_20121109_029.jpg</p>

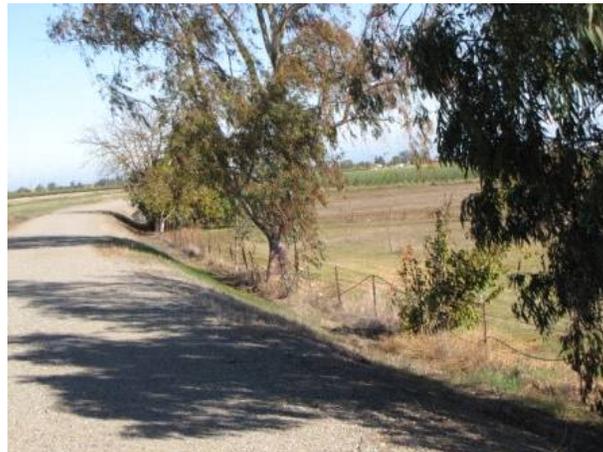
Levee Mile Report Line	127
Start Levee Mile	11.47
End Levee Mile	11.64
Location	Land Side
Category	Earthen Levee
Item	Encroachments
<p>View of a fence at the landward toe looking upstream.</p>	
<p>pkazi_f_20120913_222.jpg</p>

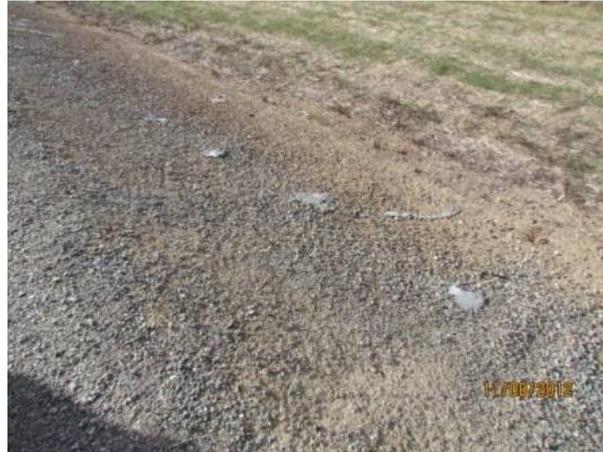
pkazi_f_20121109_030.jpg

Animal holes were grouted by the LMA on the waterside slope of the levee looking downstream.
